LOM PRAHA
s.p.

INFORMATION BULLETIN

No. M 4-III/18
M 6-III/13
M 332/30
M 337/18

Concerning: Removal and installation of circlips of the piston pin at the M 4-III, M 6-III, M 332 and M 337 engines.

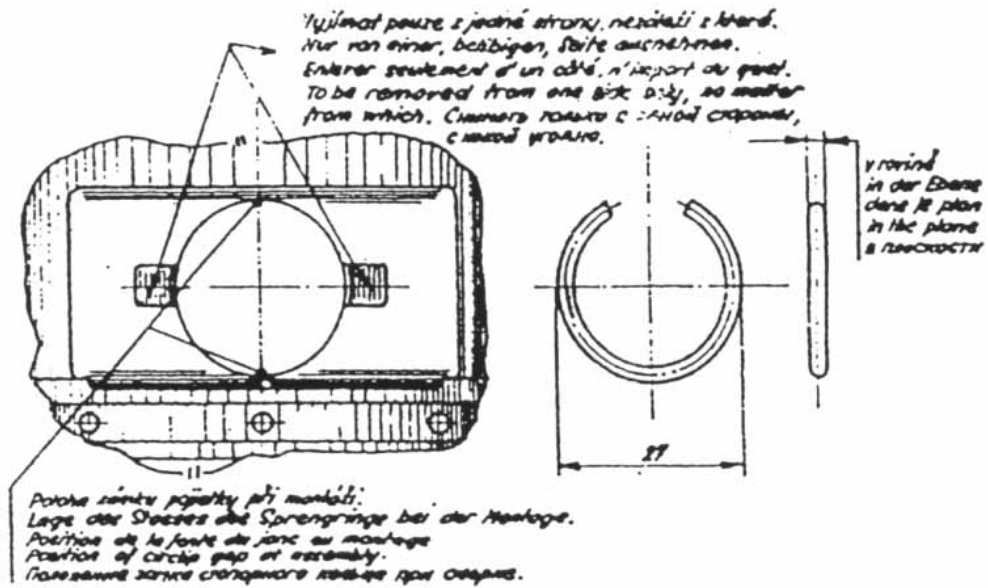
Reason: Serious defects caused by circlips of the piston pin after the prescribed partial revision of engines at the operator.

Actions: Perform removal of piston circlips with a screwdriver with a rounded edges and from one side only, as shown in the picture. During taking out the circlip you may not help the circlip in other places with a screwdriver so that the piston is not damaged in vain.

Before a new installation of the circlip, check the same. In its free status the circlip must have a dimension of 27 mm, must be flat and must not be repaired in any way! At its installation the lock of the circlip must be in the axis of the piston!

In case the circlip does not meet the specified conditions, it must be replaced by a new one. Perform the installation (insertion) of the circlip only using the prescribed pushing device Dwg. No. Z2-01503-00.
