# LOM PRAHA

**INFORMATION BULLETIN No.:** M132A/4b

**CONCERNS:** Ignition magnetos PAL-LUN 2225 and PAL-LUN 2221.13.

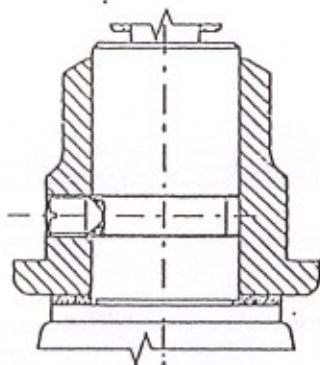
Original sealing design.

**CAUSE:** Ignition magneto sealing improvement against oil leakage from crankshaft case.

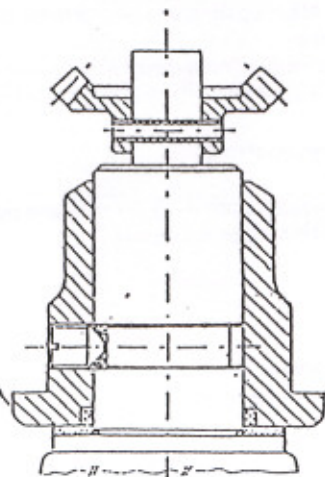
New sealing design.

"D" marked place

**MEASURES:** There is made a new design improvement. Original and new sealing pictures, see page 2/2. New sealing design is realised since 03/01 95 for engine O/H. New sealing design is marked with letter "D". See marked place on 2/2 page. Ignition magneto missing this marking in insertion piece and shows oil leakage is possible to send to LOM s.e., because for teeth wheel installing on the magneto shaft is necessary special assembly jig and installing is made by heat condition.
