## SERVICE BULLETIN

No. M 462-RF/29

**CONCERNS:** The AK-14 RF Carburetters, whereon a change in design of the accelerating pump has been realized.

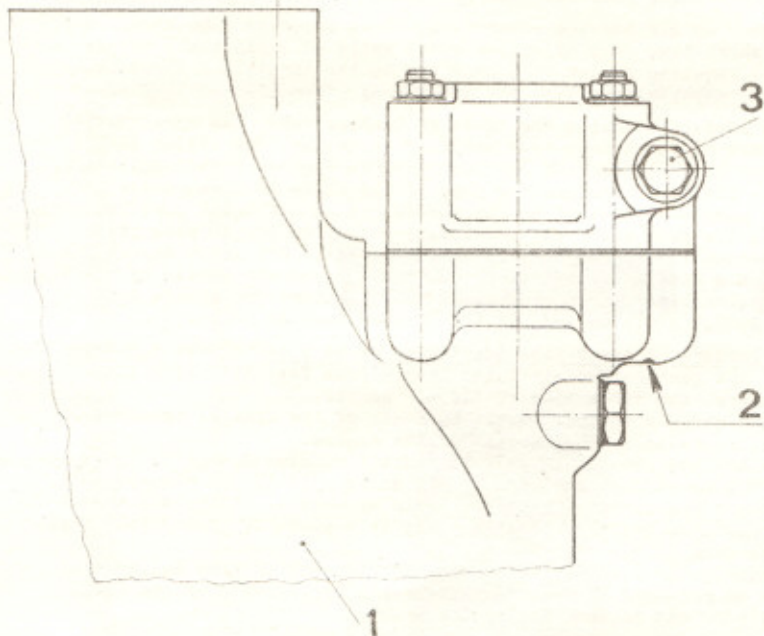
**REASON:** Based on air service experience, there occurred some cases of a short-time drop of engine speed while uncontinuously tuning the required regime of engine run by the throttle control lever, especially within the speed range from 1150 to 1500 r.p.m.

**MEASURES:** To inspect visually the AK-14 RF Carburetters, the accelerating pumps of which have been modified in design. The visual inspection is to be carried out according to Fig. 1 of this Bulletin. The modified accelerating pump of the AK-14 RF Carburettet can be easily recognized by the absence of an air inlet port (connecting the room under the accelerating pump diaphragm with the surrounding atmosphere) in the carburettet air inlet branch. In such a case it is necessary to dismount the air nozzle of the accelerating pump (see Fig. 2) and to rebores the nozzle hole to dia. 0,9 + 0,1 mm and, to fit in then back in place.

- 1 - Carburetor air inlet branch
- 2 - Air inlet hole of the carburetor original design (preceding the modification - see text)
- 3 - Air nozzle and screw plug

Procedure of the Design Adaptation to be done: On the L.H. side of the carburettet air inlet branch (see Fig. 1) unlock and unscrew the screw plug of the air nozzle.

Then unscrew the air nozzle by means of the special screwdriver incorporated in the toolkit of the engine.

Rebores the air nozzle hole by a drill of dia. 0,9 mm to 0,9 + 0,1 mm and, at last deburr the sharp edge of the rebored hole. Then screw in the air nozzle again as well as in the air nozzle screw plug and lock it as usually by a piece of zinc-plated locking wire of dia. 0,8 mm.
