SERVICE BULLETIN

M 137 A/11a
M 137 AZ/6a
No. M 337 A/5a
M 337 AK/2a

- CONCERNS:** Modification of the venting system of the LUN 5150.01 injection pumps, used on the M 137 A, M 137 AZ, M 337 A and M 337 AK aircraft engines.

Instruction
for the modification of bottom ball valves
on the LUN 5150.01 injection pumps

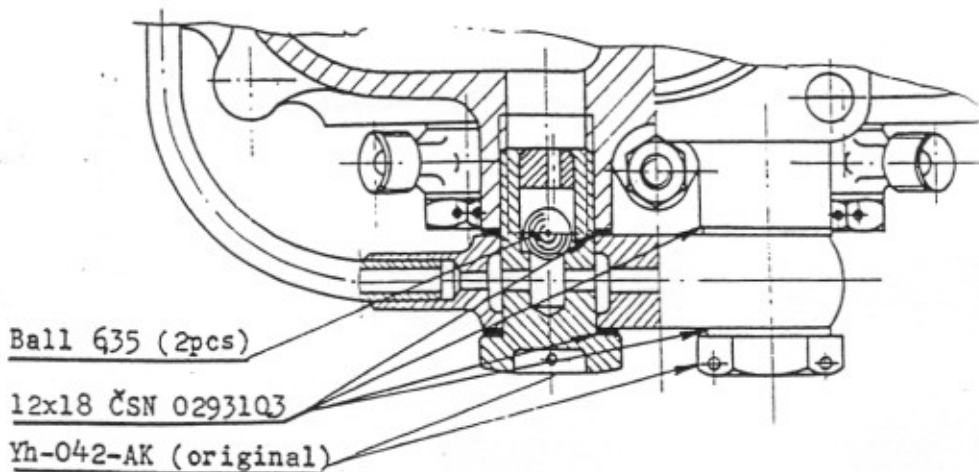
Original design

- REASON:** During the aerobatic operation of the aircraft the drossing of fuel flow can take place, what causes filling of injection pump by air.
- MEASURES:**

(with balls $\varnothing 6,35$ in the bottom valves)

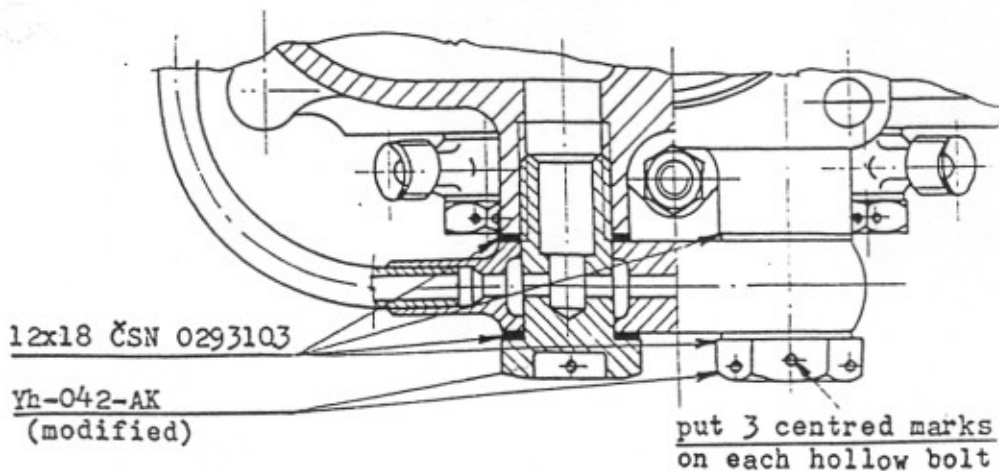
Modification of the bottom valves

(without balls $\varnothing 6,35$ and brass plugs)

3. Fix step by step both bottom ball valves Yh-042-AK for their hexagonal parts into the vice of the drilling machine and carefully drill off the brass plug leading the drill through the excentric hole of \varnothing 2 mm. For drilling use the drill \varnothing 5,5 mm, depth max. 5,5 mm.
After drilling the hole \varnothing 5,5 mm extract the brass plug together with the ball \varnothing 6,35 from the hollow bolt.
Clean and eliminate the fins after drilling.

4. Drill or hammer 3 marks of \varnothing 1,5 mm on the 3 surfaces of the hexagonal parts of both bolts (surfaces without securing holes). Clean the fins by file. The marks distinguish the original and modified designs of valves.

5. Wash both modified hollow bolts in the clean technical gasoline and blow them out by pressed air.
6. Screw in the both modified hollow bolts carefully together with proper sealing washers 12x18 ČSN 02 9310.3 by means of twin connection of the bypassing tube of the venting system into the fuel chamber, using the spanner 17 mm.
Pay attention to the possibility of M 12x1,5 thread deterioration in hollow bolts.

7. Check the tightness of all connections of fuel chamber by overflowing the injection pump with fuel by means of overflowing pump.
8. After checking the tightness both hollow bolts are to be secured against selfturning by means of mild securing wire \varnothing 0,8 mm.
