**SERVICE BULLETIN**

No. M 137A/4  
M 337/68

**CONCERNS :** Inspections and operation of the LUN 2221.13 starting magneto.

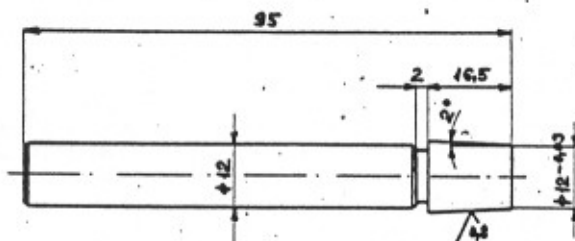
Obr. 1  
Fig.1 - Øxr.1

- 1) Check duly fixed fitting of the ignition distributor arm on the slit carrier pin of the distributor cam. This check is to be performed by trying to deflect radially the ignition distributor arm, however, in fact the arm is to be sufficiently fixed, not deflectable and not anyhow rocking. If the arm is found rocking, it is to be taken off and the carrier pin slit of the cam is to be slightly opened (it is recommended to use for this operation a mandrel illustrated in Fig.1)

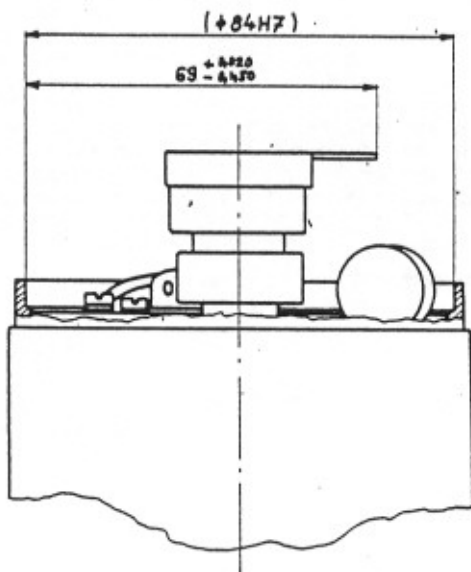
Obr. 2  
Fig.2 - Øxr.2

Then check the extend of pitting (burning) of the ignition distributor arm electrode in accordance with the attached Fig.2. The actual size is to be kept up within  $69^{+0,02}_{-0,45}$  mm. If the actual size is less than the specified one, the spark ignition distributing arm is to be replaced with a new one and recheck the size (see Fig.2) again.
